Subject: Notice of Violation No. R9-2014-0123, Concrete Collaborative, General NPDES Permit No. CAS000001, Order No. 97-03-DWQ, for Discharges of Storm Water Associated With Industrial Activities

NOTICE OF VIOLATION
No. R9-2014-0123

FACILITY INSPECTION REPORT

FACILITY: Concrete Collaborative **INSPECTION DATE/TIME:** 10/07/2014, 10:30 hrs

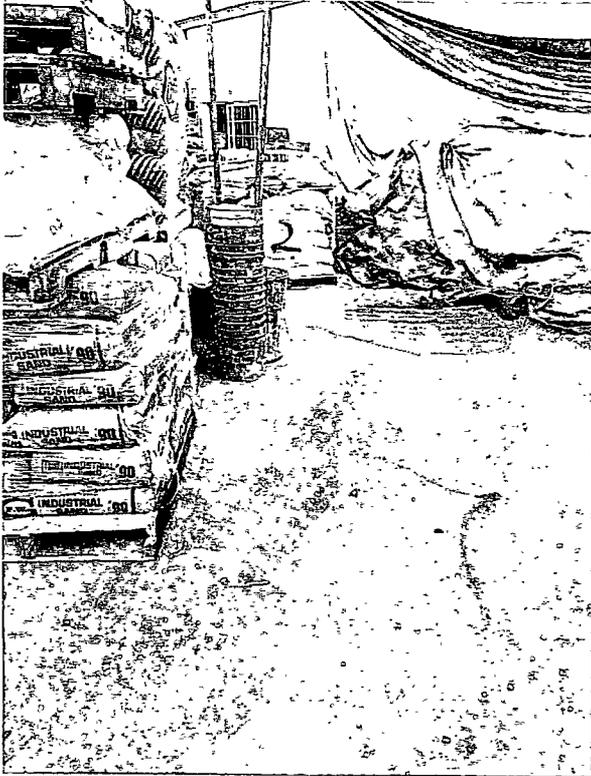
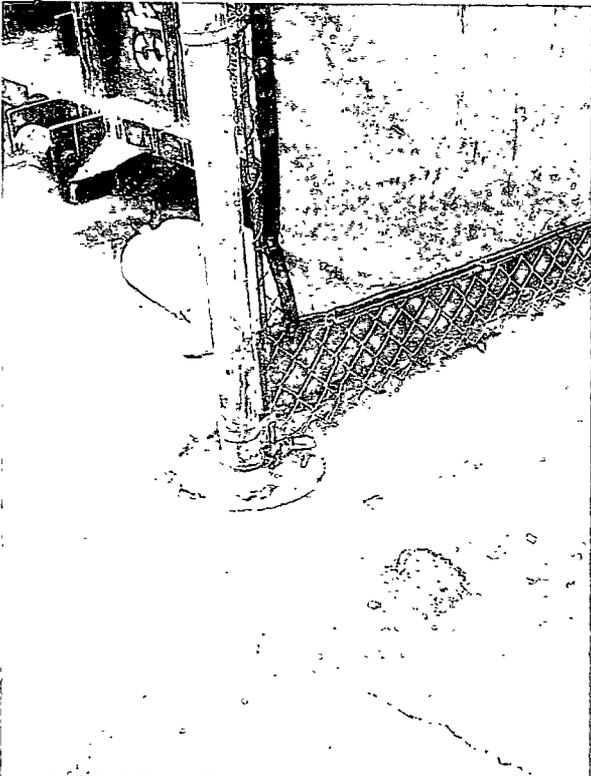
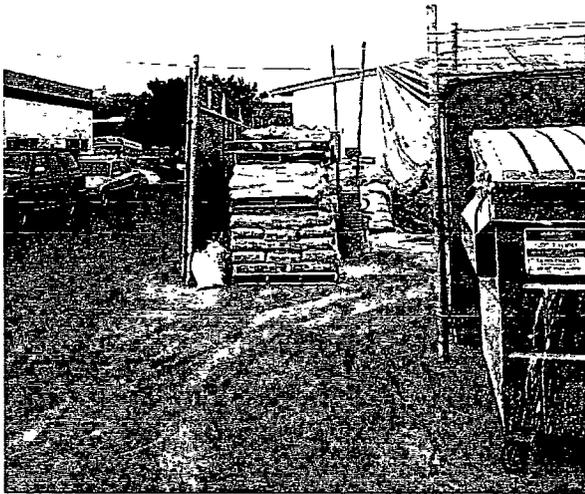
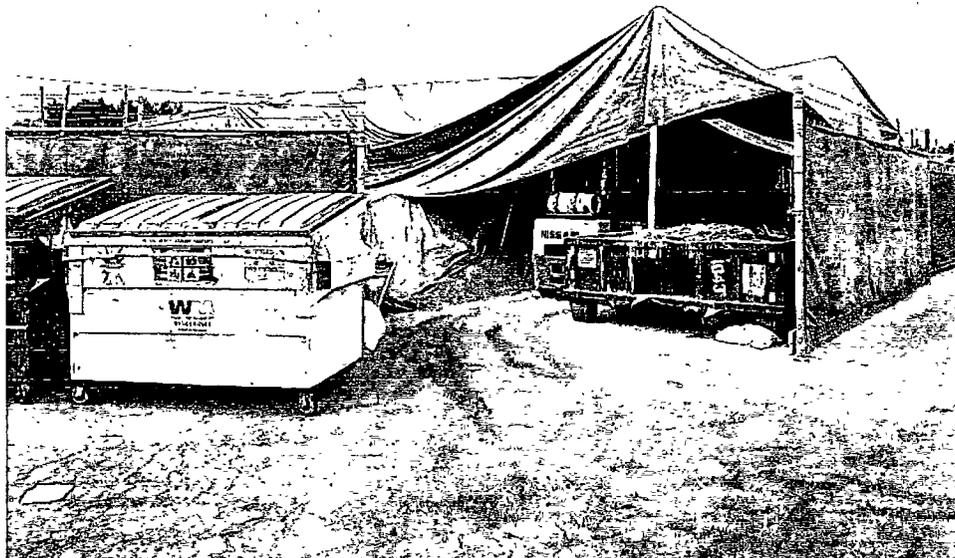
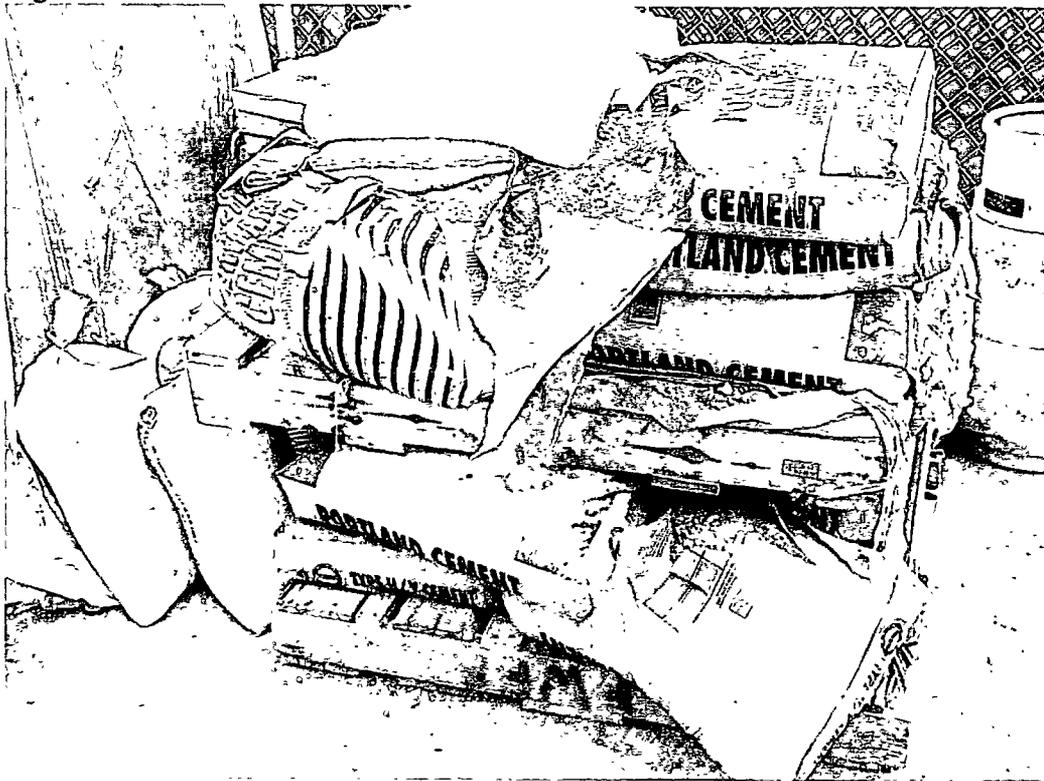
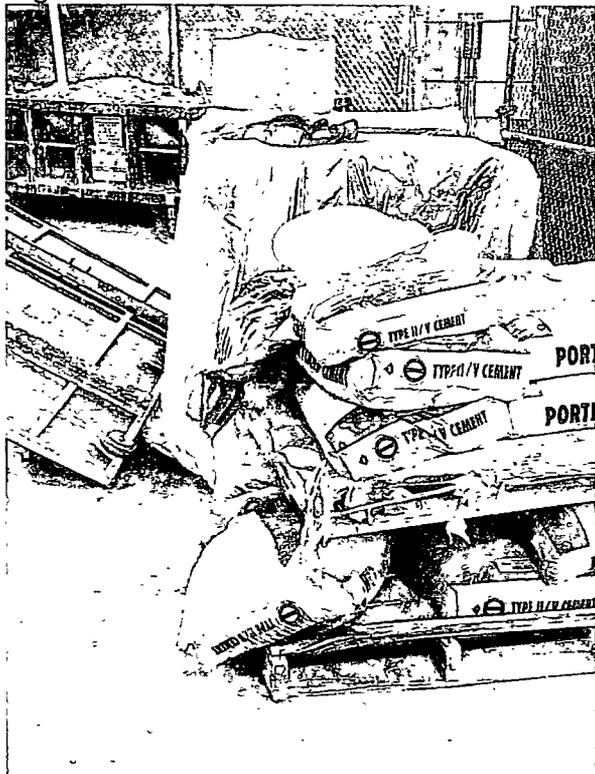
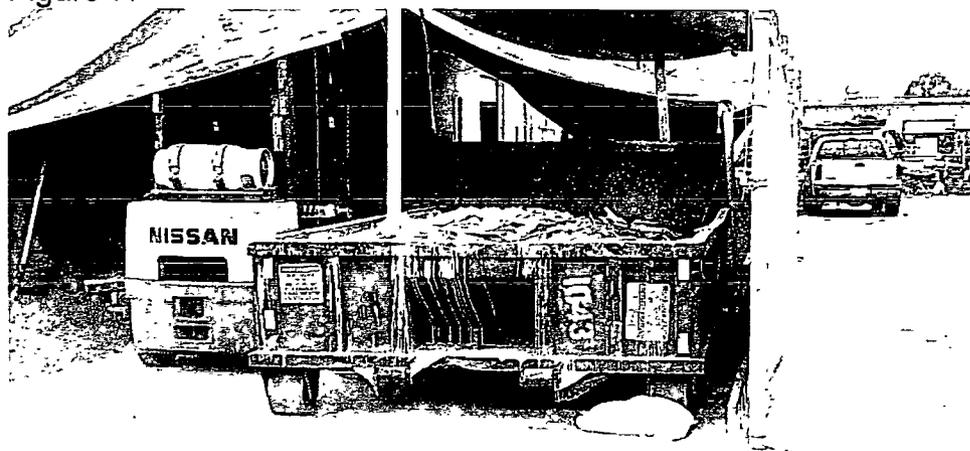
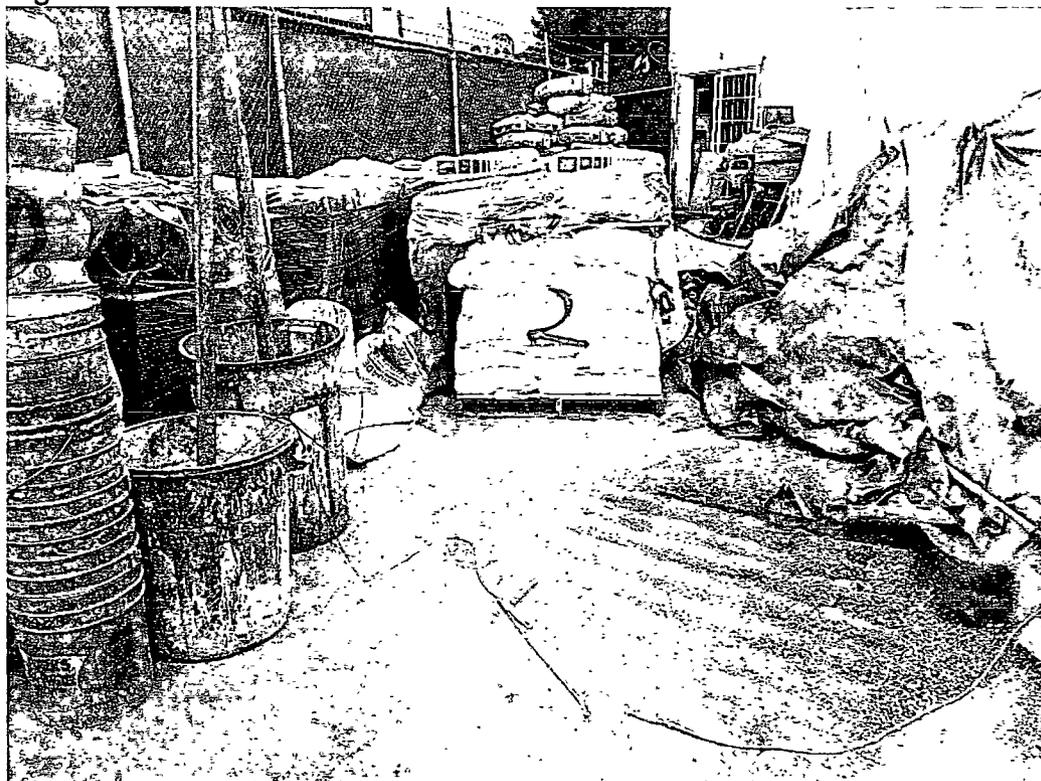
1. Housekeeping BMPs remain inadequate. Tracking of process materials off site in the yard area persists. There are torn open bags of Portland cement exposed outside in the yard. Sand, gravel and other process materials are also exposed on the ground at the site (See attached photos 1 – 8).

1. Require the discharger to eliminate exposure of the torn bags of Portland cement and completely cover stockpiles of other process materials. Require the discharger to fully implement housekeeping BMPs.
2. Require the discharger to install adequate structural overhead cover.
3. Require the discharger to close gaps in the concrete block & mortar curb prior to a rain event.
4. Require the discharger to update the SWPPP to reflect all required content and information, as well as fully implement the SWPPP.

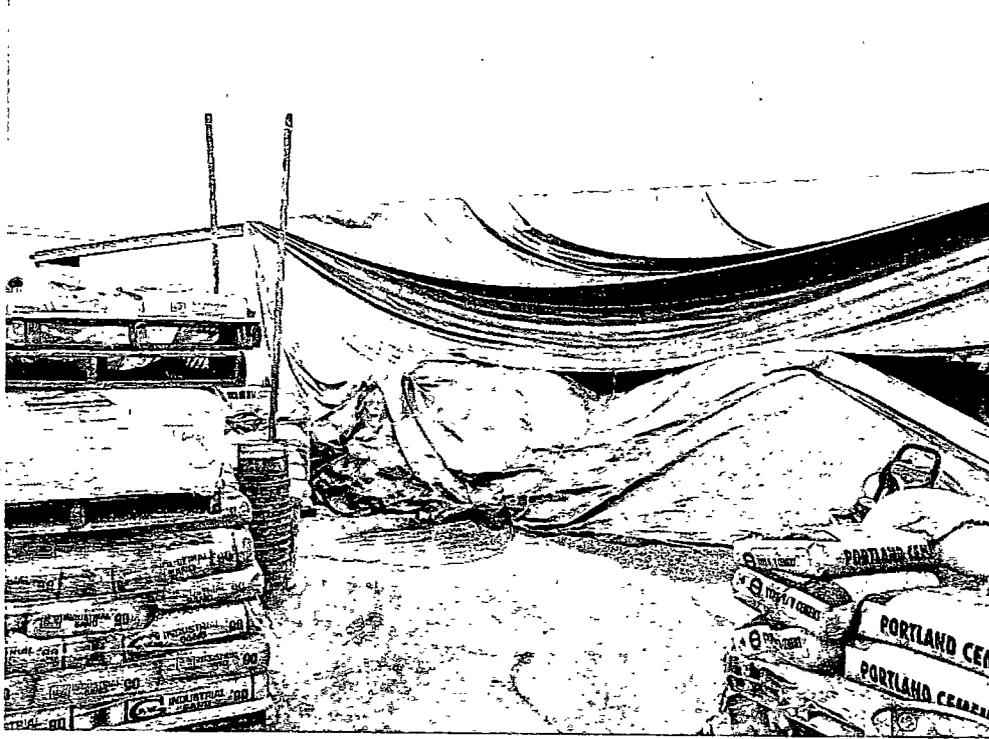
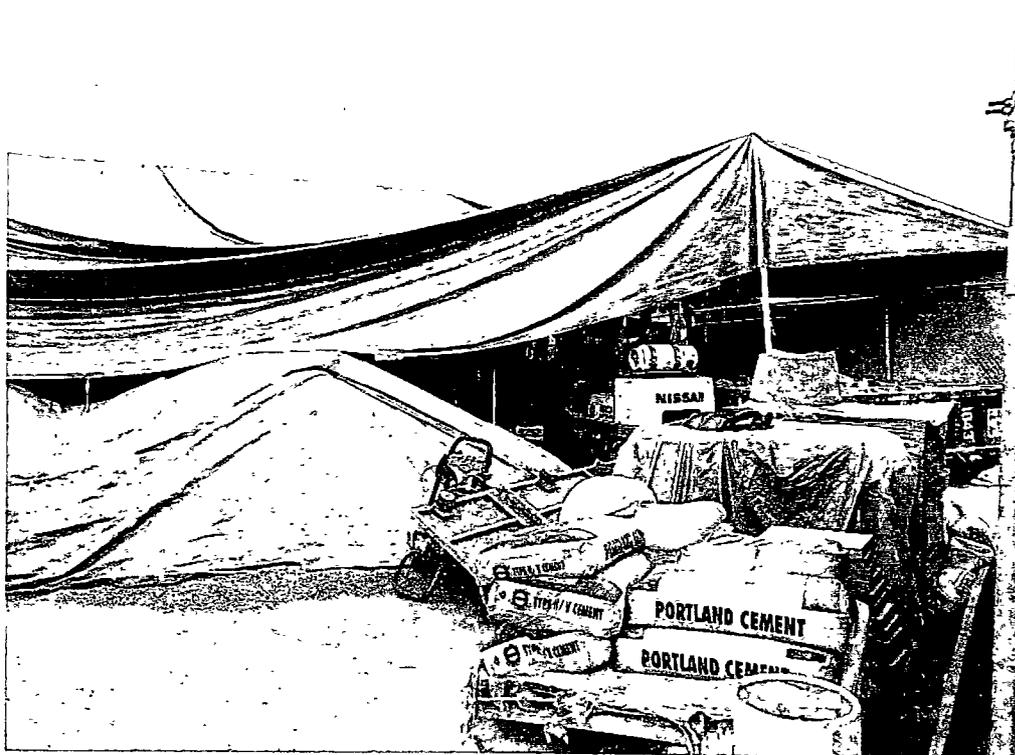
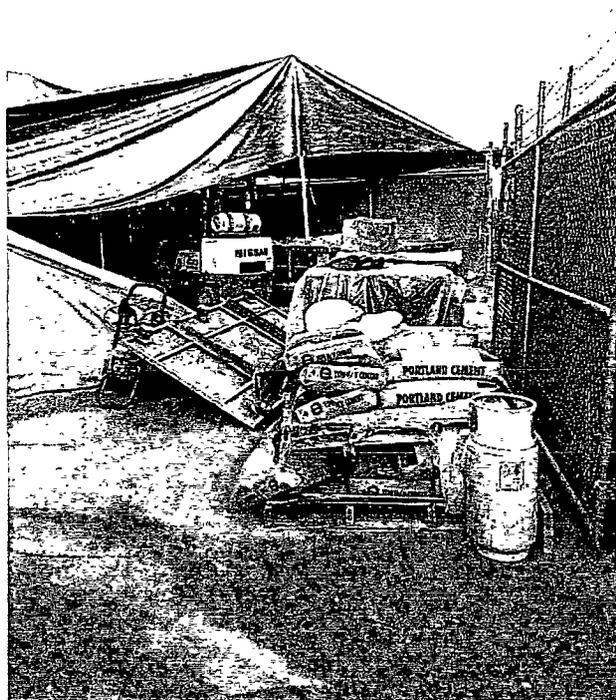
2. Structural overhead cover remains inadequate. Tarps that were installed are not adequate corrective actions (inadequate perimeter controls and overhead cover). Tarps are not structural overhead cover, and are not effective in preventing storm water from coming into contact with processes and materials (See attached photos 9 – 11).

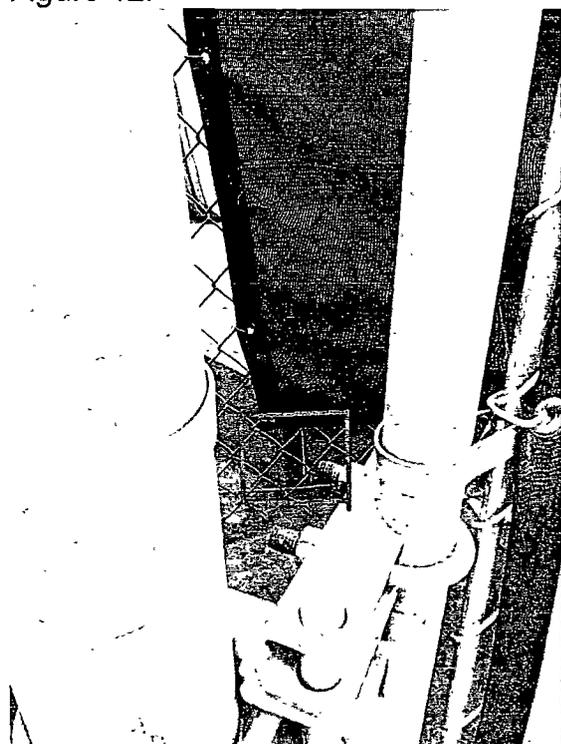
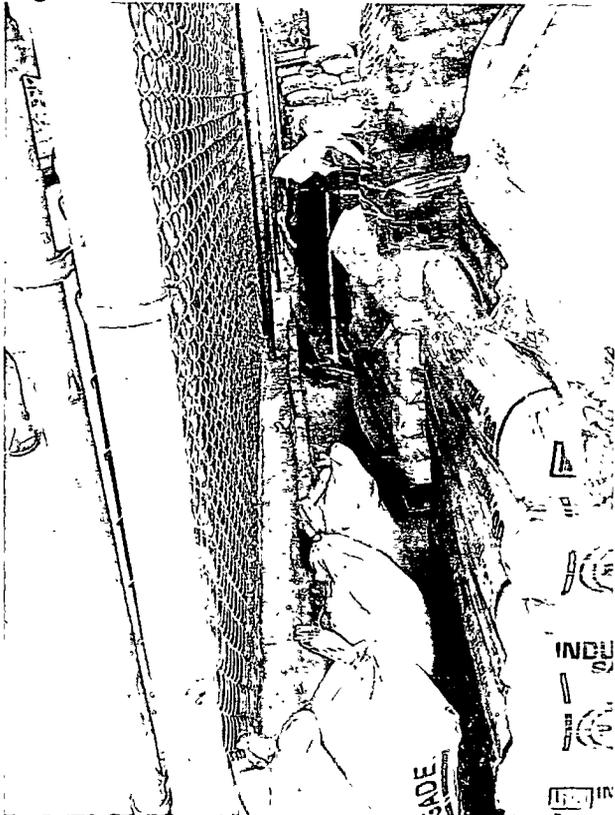
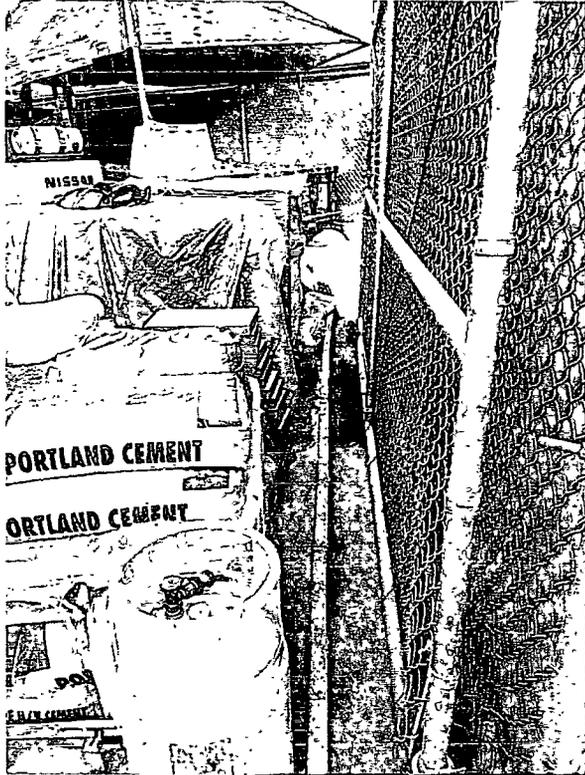
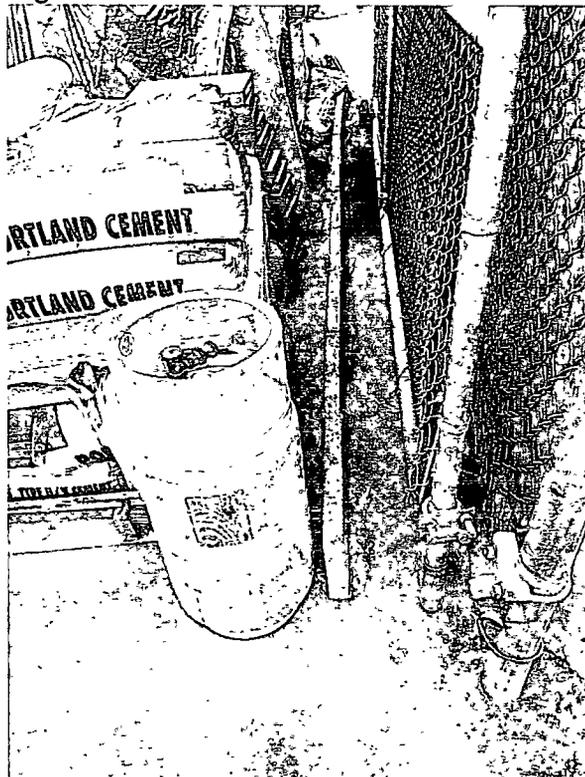
3. Structural perimeter controls remain inadequate. The concrete block and mortar curb installed along the perimeter at the fence line has small gaps in some locations where storm water and process waste can flow through and off site (See attached photos 12 – 16).
